Improving Train Station Design

Pedestrian flows
train station Oerlikon

Ernst Basler
+ Partner AG

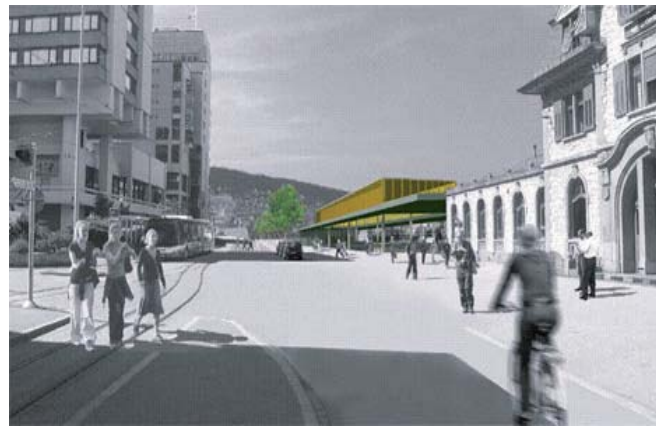
The simulation study compared two different train station upgrading scenarios: one called „underpass with platform connection“, the other „underpass without platform connection“. Software requirements for this case entailed pedestrians choosing routes

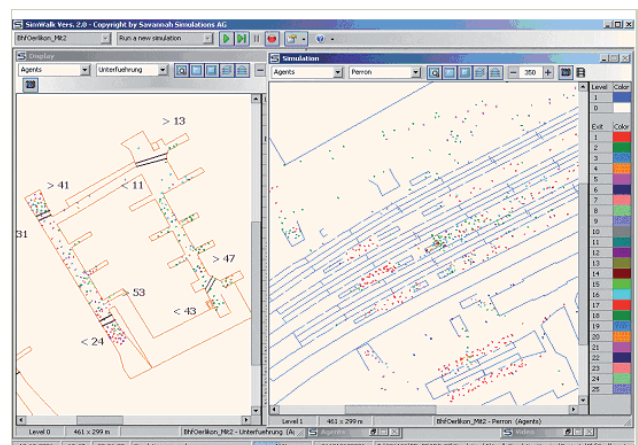
depending on available capacities, densities (bottlenecks) and number of pedestrians in the system. Additionally, the software had to allow modeling of stairs based on actual capacity. The simulation study with SimWalk showed the displacement of pedestrian flows, depending on the different upgrading scenarios of Oerlikon train station. Further simulation results were, firstly, the discovery of capacity bottlenecks of platform stairs leading down to the underpass. Secondly, additional bottlenecks were discovered at the entrance stairs to the underpass, connecting train station forecourt and underpass.
